# **GEOTECHNICAL INVESTIGATION FOR PORTION 20 OF FARM 23, PATERNOSTER, WESTERN CAPE.**

17 MARCH 2026  
GEOSS Report No.:2026/03-12

**GEOSS**  
Groundwater & Geo-Environmental Solutions

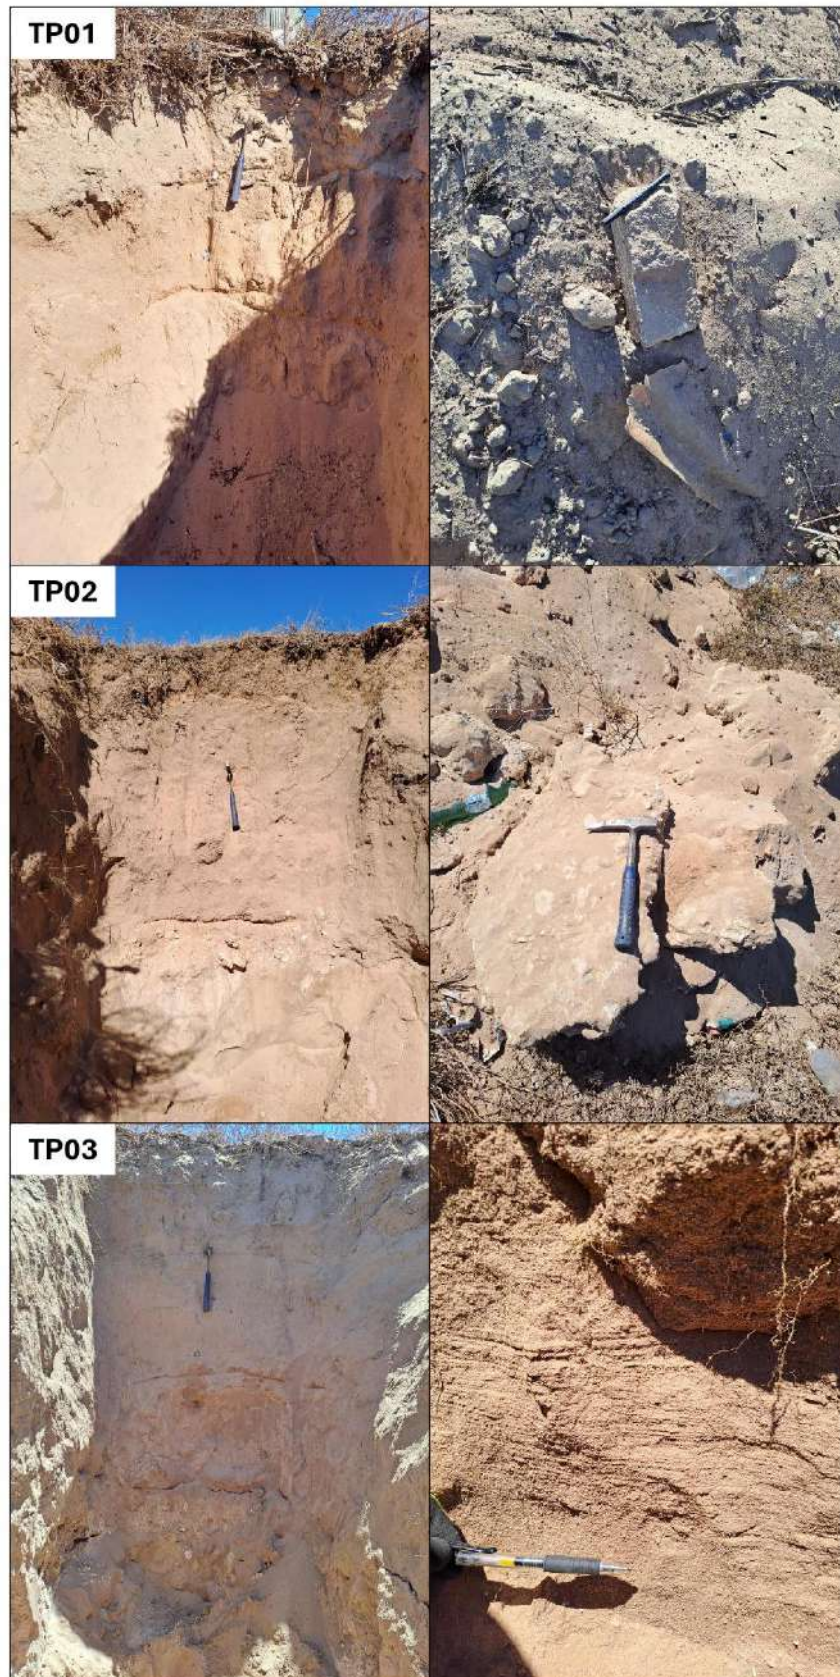
Figure 5: General soil conditions recorded during trial pitting at TP01 displaying full profile depth and fill comprising the topmost horizon; TP02 displaying full profile depth and **HARDPAN CALCRETE** at 2.30 mbgl excavatable with TLB just prior to refusal; TP03 displaying full profile depth and medium dense fine-grained **SAND** between 0.70 – 1.90 mbgl.

During the fieldwork component of the study, five TPs were excavated across Portion 20 of Farm 23. The soil profiles are primarily characterised by loose to medium dense **SAND**, with pedogenic horizons encountered at various depths. Refusal occurred in all TPs due to strongly cemented **HARDPAN CALCRETE**. The depth of refusal varied notably across the study area, ranging from as shallow as 1.40 - 1.70 mbgl to depths of 2.30 - 3.50 mbgl.

All materials overlying the **HARDPAN CALCRETES** were successfully excavated using light earth-moving equipment, i.e., TLB. Consequently, these subsurface soils are classified as 'soft excavation' in accordance with COTO (2019) standards. However, the discontinuous **HARDPAN CALCRETES** horizons that caused TLB refusal will likely require heavier machinery, such as a 30t excavator or rock-breaking equipment, for example, excavator-mounted peckers. As a result, **HARDPAN CALCRETES** may be classed as 'hard excavation' conditions according to COTO (2019) standards.

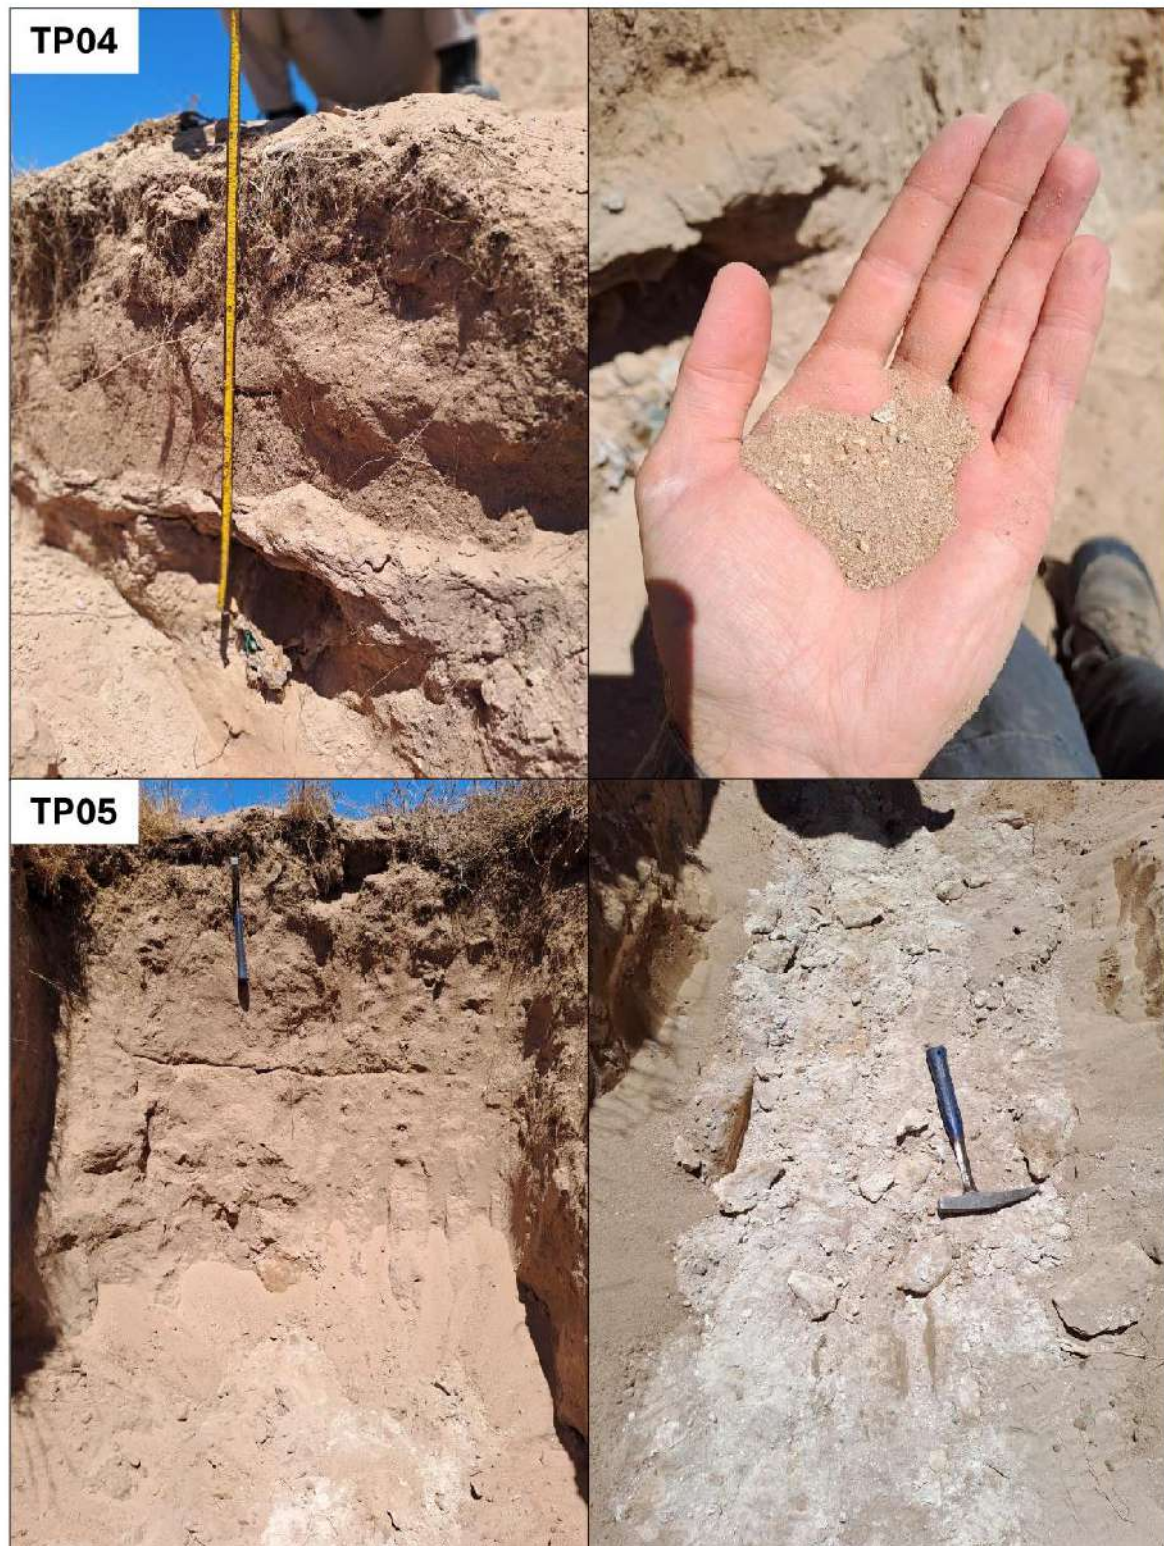
*Figure 6: General soil conditions recorded during trial pitting at TP04 displaying full profile depth and transported **loose SAND** comprising the topmost horizon; TP05 displaying full profile depth and refusal on **HARDPAN CALCRETE** at a depth of 1.40 mbgl.*
